**TRAFFIC SAFETY
IMPROVEMENT STUDY**

WO No. 91-06

CITY OF BILLINGS

MA **MARVIN & ASSOCIATES**
Traffic, Transportation & Civil Engineers

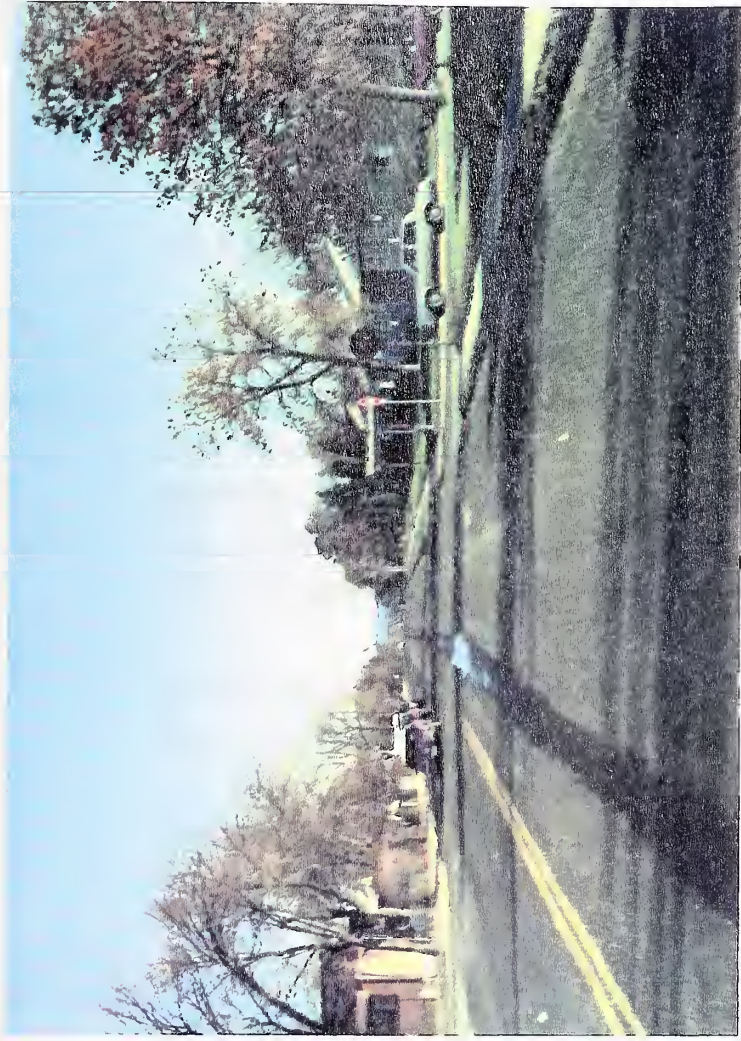
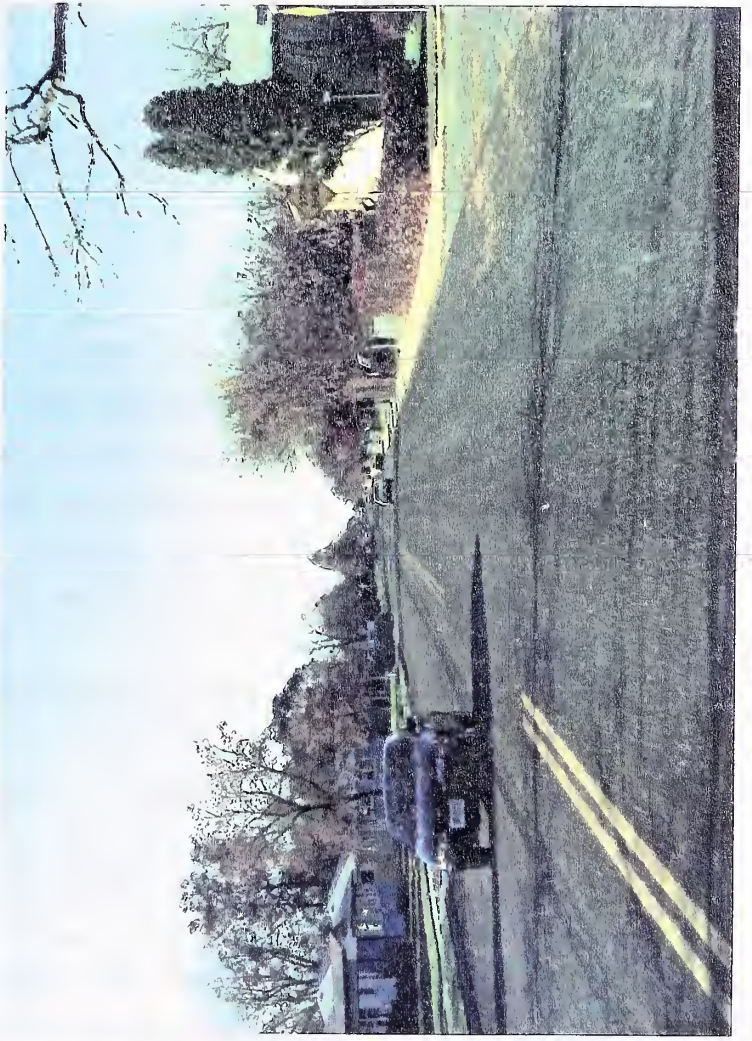
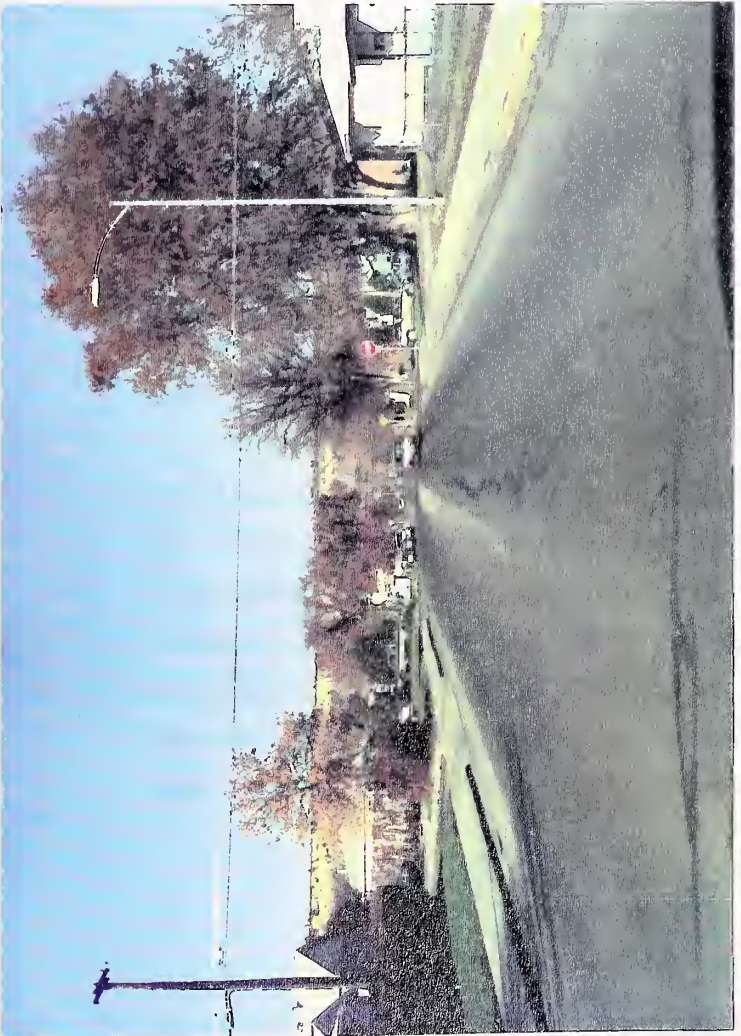
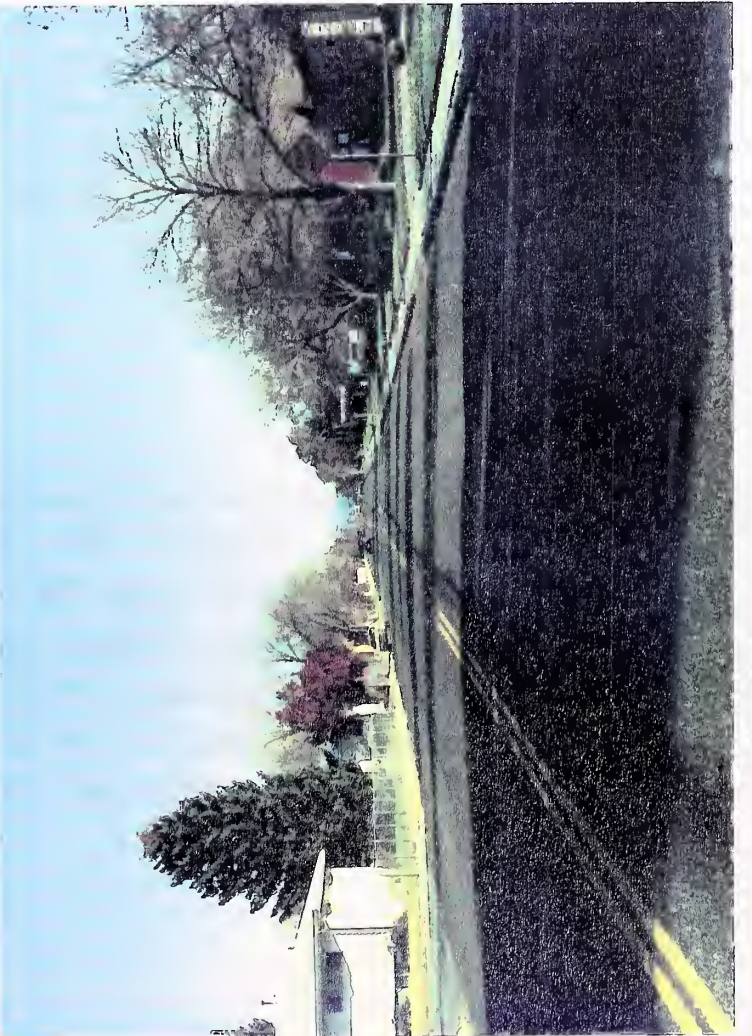
19TH ST. W. LOOKING SOUTH

LEWIS AVE. LOOKING WEST

19TH ST. W. LOOKING NORTH

LEWIS AVE. LOOKING EAST

Both streets are two lane streets with parking both sides, however there is no significant parking demand in this area. Sight distance for the type of operations involved at this location is good. There are stop ahead signs posted on Lewis in both directions. The need for them is clear, since this intersection is the only stop between 16th Street W. and 24th Street West. Lewis is 51' wide, flat and straight and drivers can easily miss the 30" stop signs. This situation is not as critical on 19th Street West, since it is a narrower street with other stop conditions in closer proximity.

There were 5 angle accidents and nine rearend accidents during the reporting period. It is believed that a portion of the rearend accidents can be attributed to following drivers who were not cognizant of the stop condition. It should also be noted that accidents are increasing progressively with traffic volume increases.

Improvements recommended at this intersection focus on improving the chance of Lewis Avenue drivers noticing the stop condition. This can be accomplished by replacing the small faded 30" stop ahead signs with the new standard 36" symbol sign and replacing the existing stop signs with 36" signs. In addition, plastic stop bars and 12" wide crosswalk marking should be installed at this intersection to reinforce the stop condition and to alert drivers that pedestrian crossings are common at this intersection.

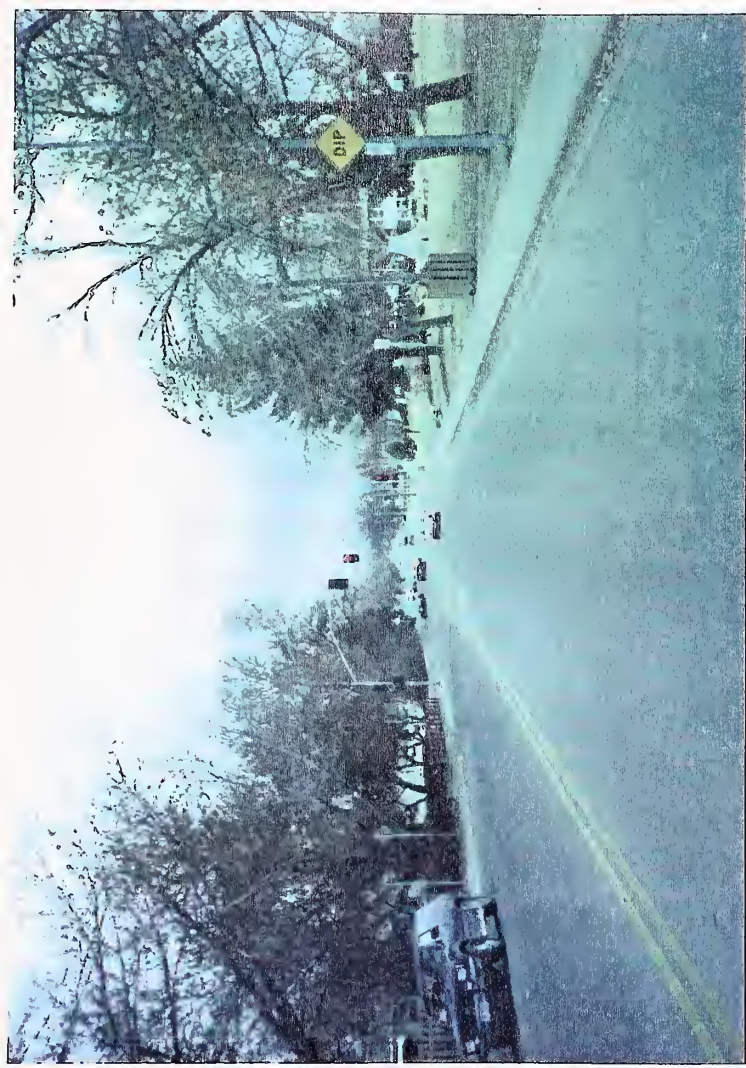
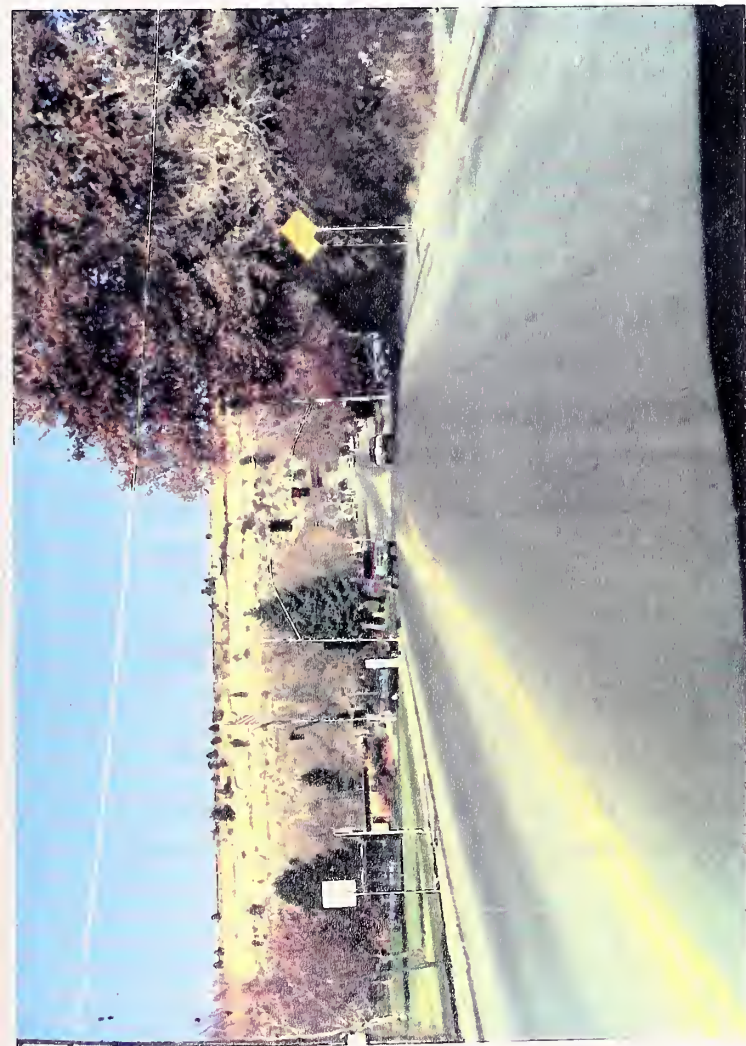
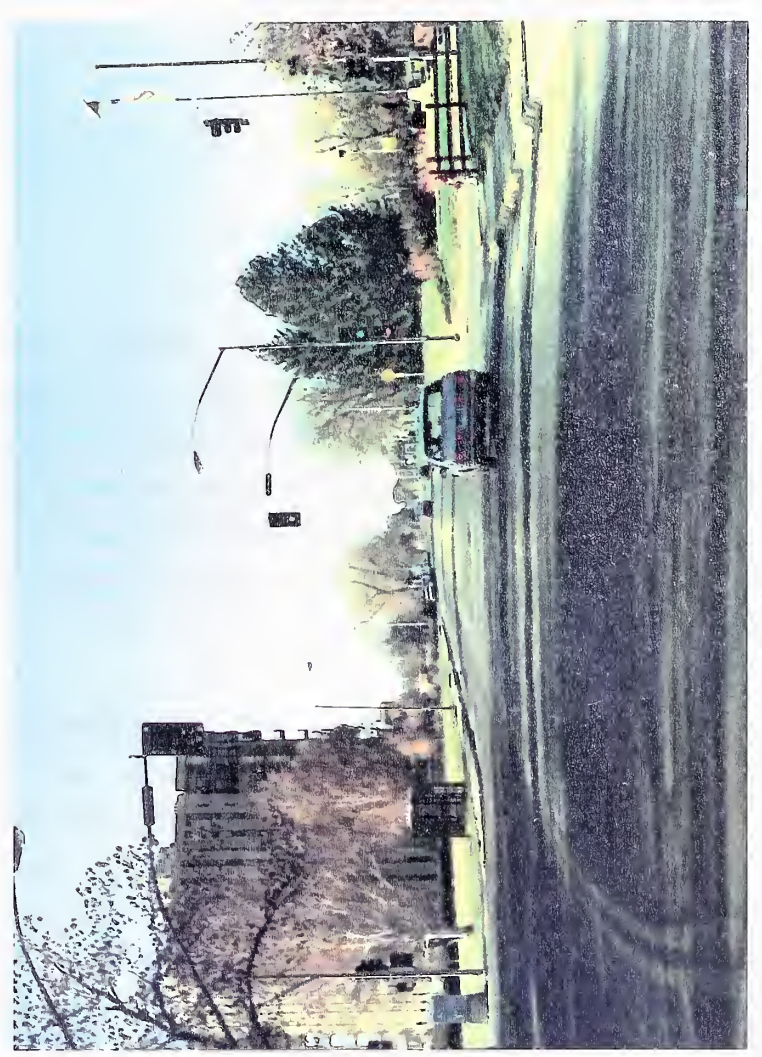
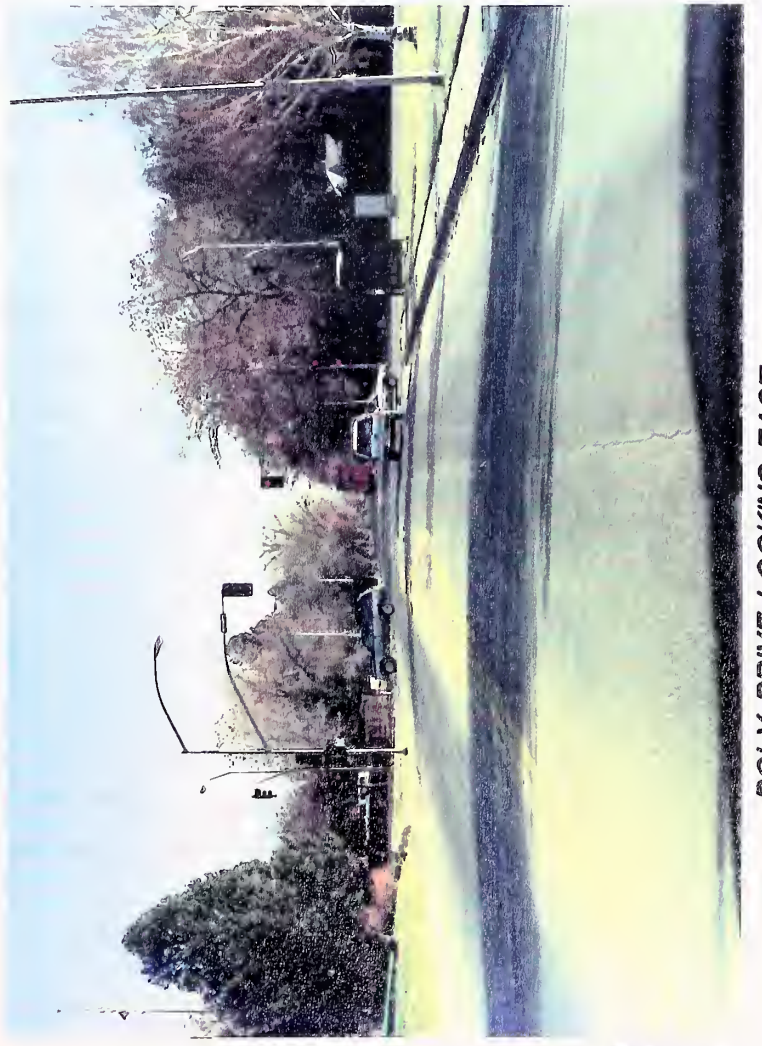
13TH ST. W. LOOKING SOUTH

13TH ST. W. LOOKING NORTH

POLY DRIVE LOOKING WEST

POLY DRIVE LOOKING EAST

The most noticeable feature of this intersection is the pavement surface especially on the west side of the intersection. The street cross section was built with a quarter crown in the north portion of the street. Since the south curb line is quite a bit lower than the north curb, the street has a extreme cross slope near the intersection. The combination of cross slope and vehicle deceleration and acceleration has created pavement ridges near the edge of the left turn lane. The ridges are 4 to 6" high in spots. The ridges tend to deflect vehicles even when the road is dry. It was noted that some eastbound thru traffic uses a portion of the left turn lane to avoid those ridges. During periods of snow or ice, thru vehicles use most of the left turn lane because the extreme cross slope can direct the vehicle into the curb. One of two sideswipe accidents and the majority of 12 rearend accidents were attributed to this condition.

With respect to traffic control, there appears to be some signs which do not relate directly to conditions at the intersection and only add to clutter and could distract drivers from critical operations. The signal heads are visible during most approach conditions, but there is only one mast mounted head per pole. Pavement markings are in poor condition. Stop bars, cross walks and words and symbols were completely worn off.

work load at a juncture which requires drivers to focus on conditions other than vehicle path alignment. Reconstruction of the street section should be extended through the intersection which may aid in eliminating a ramp or dip on the north approach to the intersection. Although no accidents were attributed to this dip, the dip can be severe at approach speeds exceeding 25 mph. Plastic markings should replace all existing painted markings which tend to wear away. The park signs in advance of the intersections should be removed because they only tend to distract drivers from important intersection control.
